SUBJECT: Hipps Road Landfill Superfund Site
Five-Year Review

Five-Year Review Report for 1995 to 1999

Hipps Road Landfill
Superfund Site
Jacksonville, Florida
EPA ID Number: FLD980709802

Date:
19 June 2000

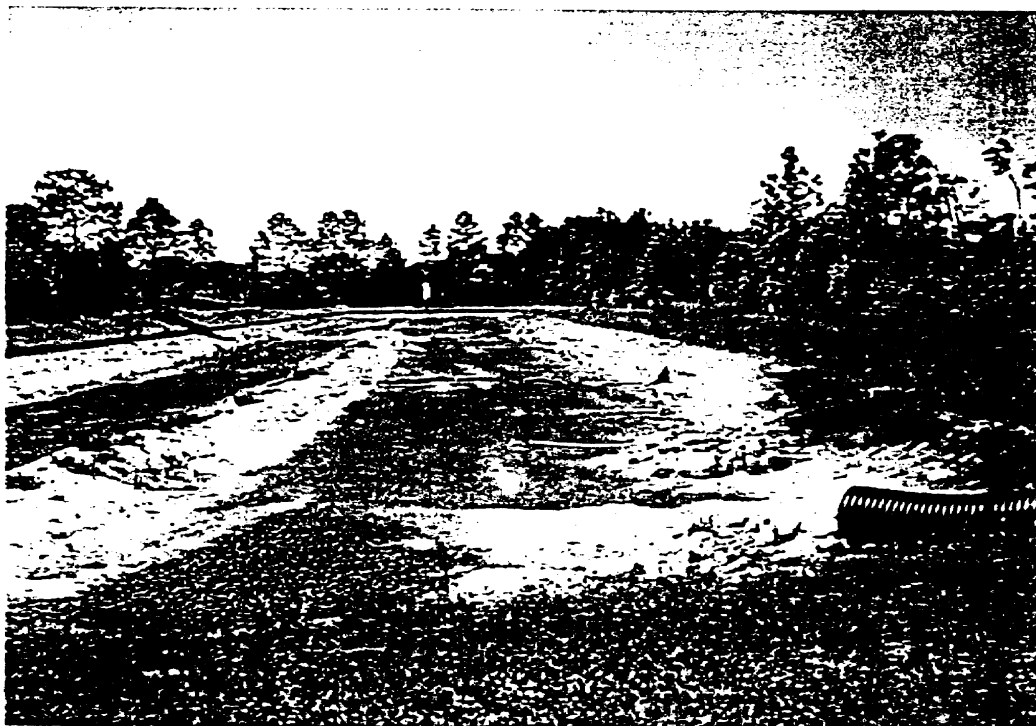
Photograph of dry retention pond taken from the northern edge of the pond. The pipe that discharges stormwater runoff from the landfill is located at the right of the photograph.

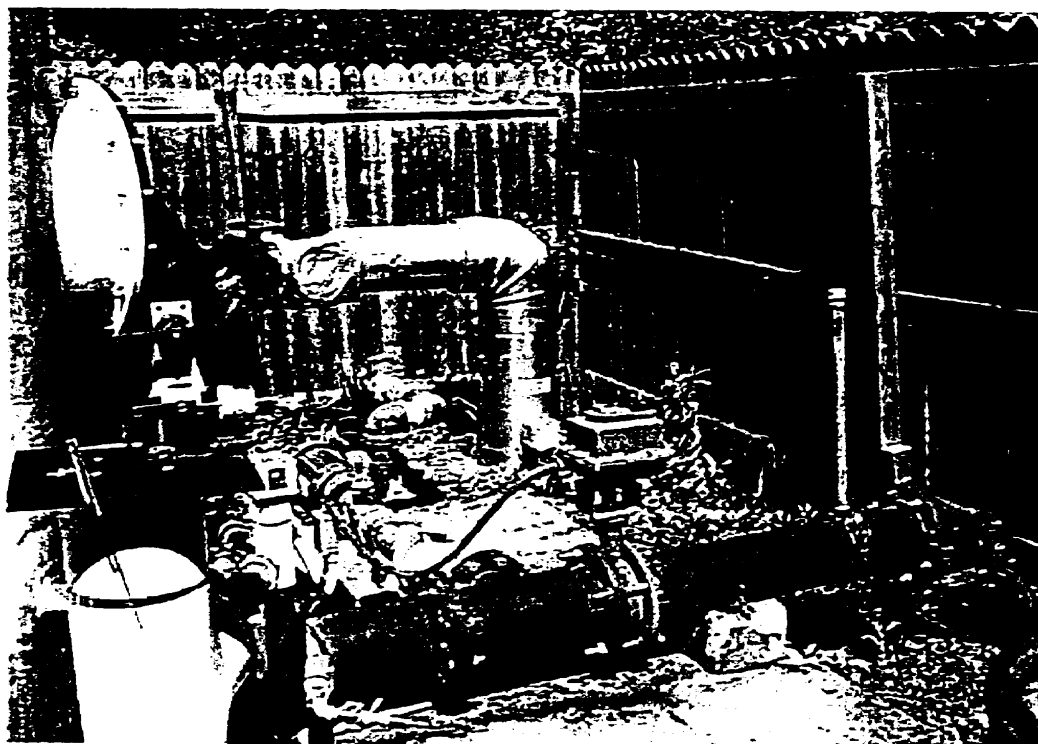
Photograph of groundwater treatment system showing POTW bypass.

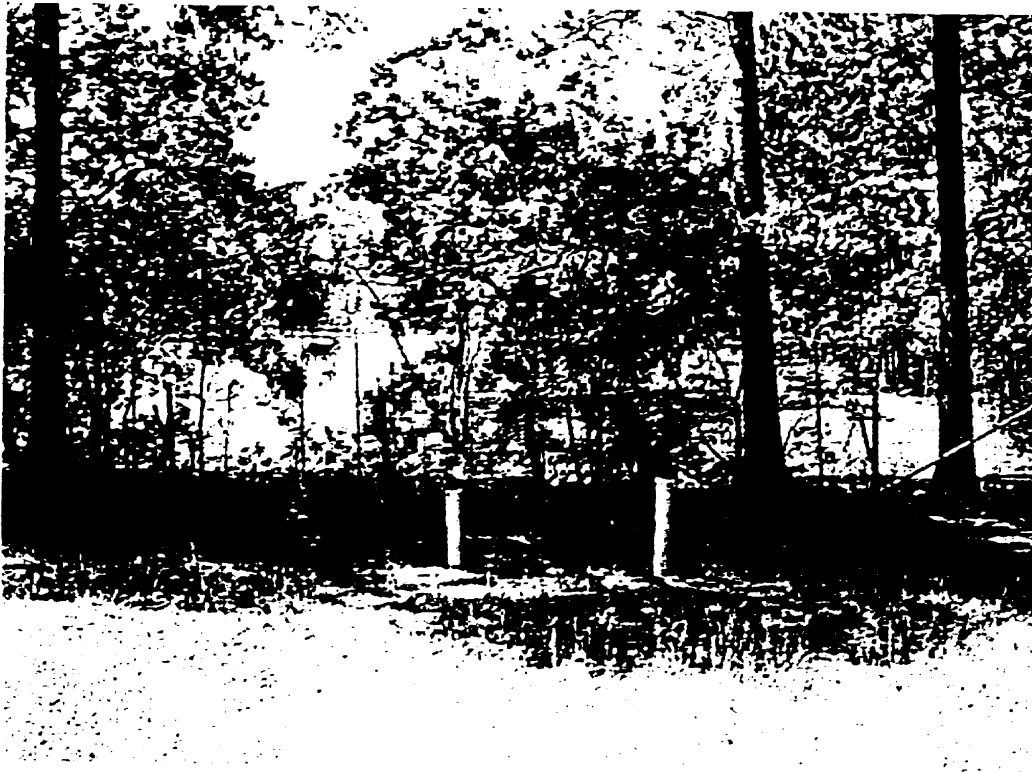
Photograph of monitoring well TMW-1 couplet located at the southwest corner of the retention pond and site fence.

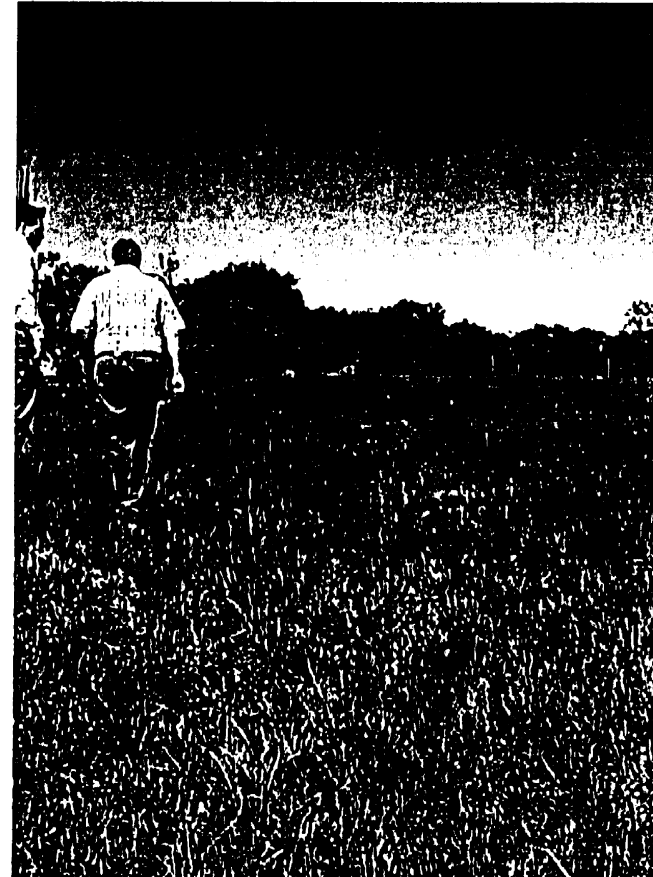
Photograph of perimeter ditch. The location is marked all grass in by taller grass.
